Manhole Inspection Summary

Manhole # S11S__020MH

Insp Date: **4/3/08 1:28 PM**

Location Address: **809 S. Caton Ave**

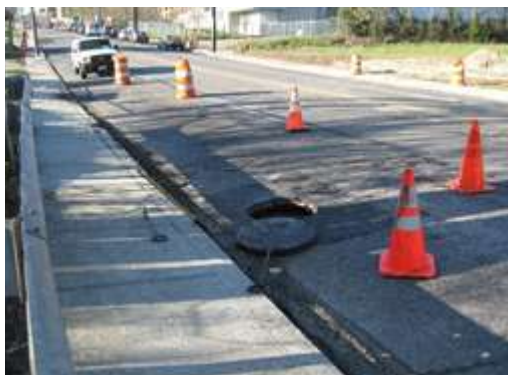
Location View

707 S. Caton Ave

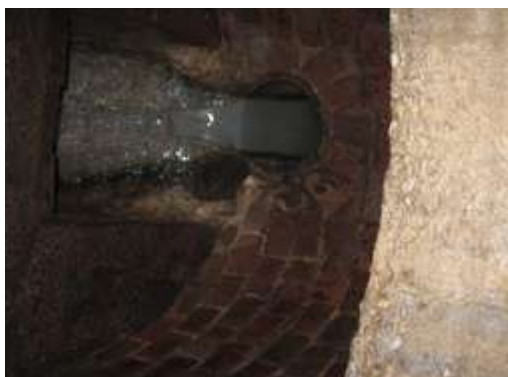
Inside drop (unable to measure)

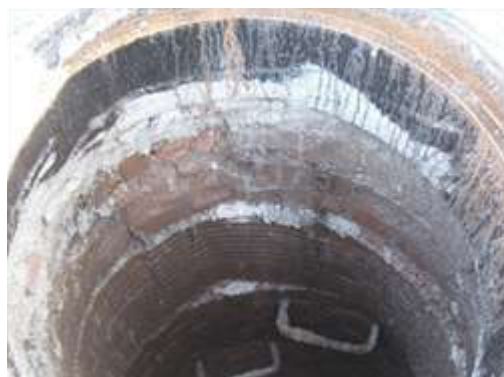
Defect 3

Condition: ☐ Sound ☐ Cracked ☐ Root Intrusion ☐ Loose Brick ☒ **Deteriorated**

Infiltration: ☐ None ☐ Joint ☐ Cracks ☐ Mortar ☐ Roots ☒ **Wall**

chimney deteriorated, Chimney and corbel infiltration

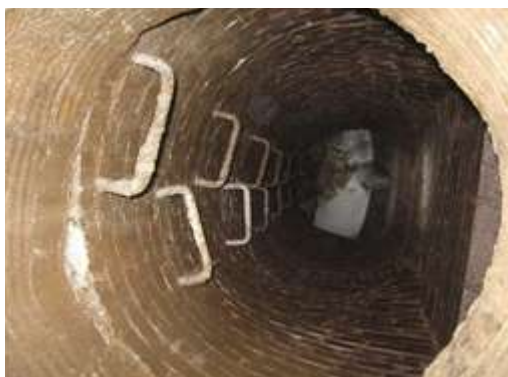
Defect 1

Corroded steps

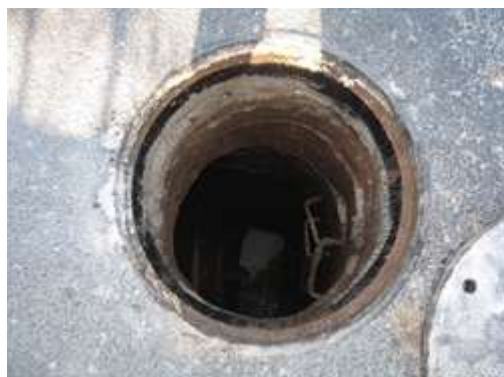
Defect 2

☒ **Leaks**

frame leaks-sheeting evidence

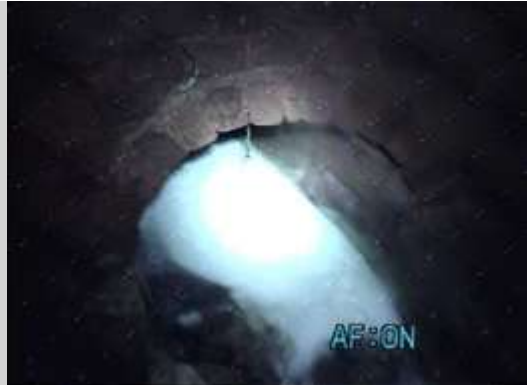
12 O'Clock Outflow

24 in. Circular Gravity Sewer
Pipe Out @ 12 O'Clock

Pipe Height: **24** (in.) Rod and Bar (Angled)
Pipe Material: **Clay** ☐ Pipe Lined
Invert Depth: **21.80** (ft.) Flow Characteristics: **Fast**
Deposits: ☒ None ☐ Mud ☐ Sludge ☐ Debris ☐ Grease
Silt Depth: **0** (in.) Deposits Extent:
Infiltration: **None** Pipe Seal Cond: **Sound**

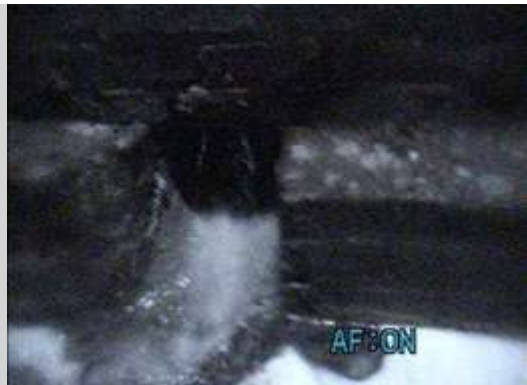
3 O'Clock Inflow

8 in. Circular Gravity Sewer
Pipe In @ 3 O'Clock

Pipe Height: **8.4** (in.) Rod and Bar (Angled)
Pipe Material: **Clay** ☐ Pipe Lined
Invert Depth: **21.60** (ft.) Flow Characteristics: **Fast**
Deposits: ☒ None ☐ Mud ☐ Sludge ☐ Debris ☐ Grease
Silt Depth: **0** (in.) Deposits Extent:
Infiltration: **None** Pipe Seal Cond: **Sound**

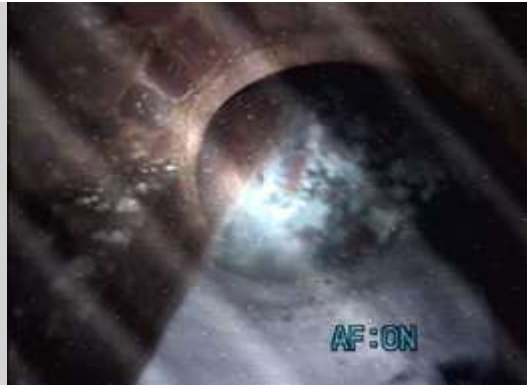
6 O'Clock Inflow

24 in. Circular Gravity Sewer

Pipe In @ 6 O'Clock

Pipe Height: **25.2** (in.) Rod and Bar (Angled)

Infiltration: **None** Pipe Seal Cond: **Sound**
